Experiences of radiation emergency medicine

National Institutes for Quantum and Radiological Science and Technology (QST)

TEPCO Fukushima NPP accident in 2011

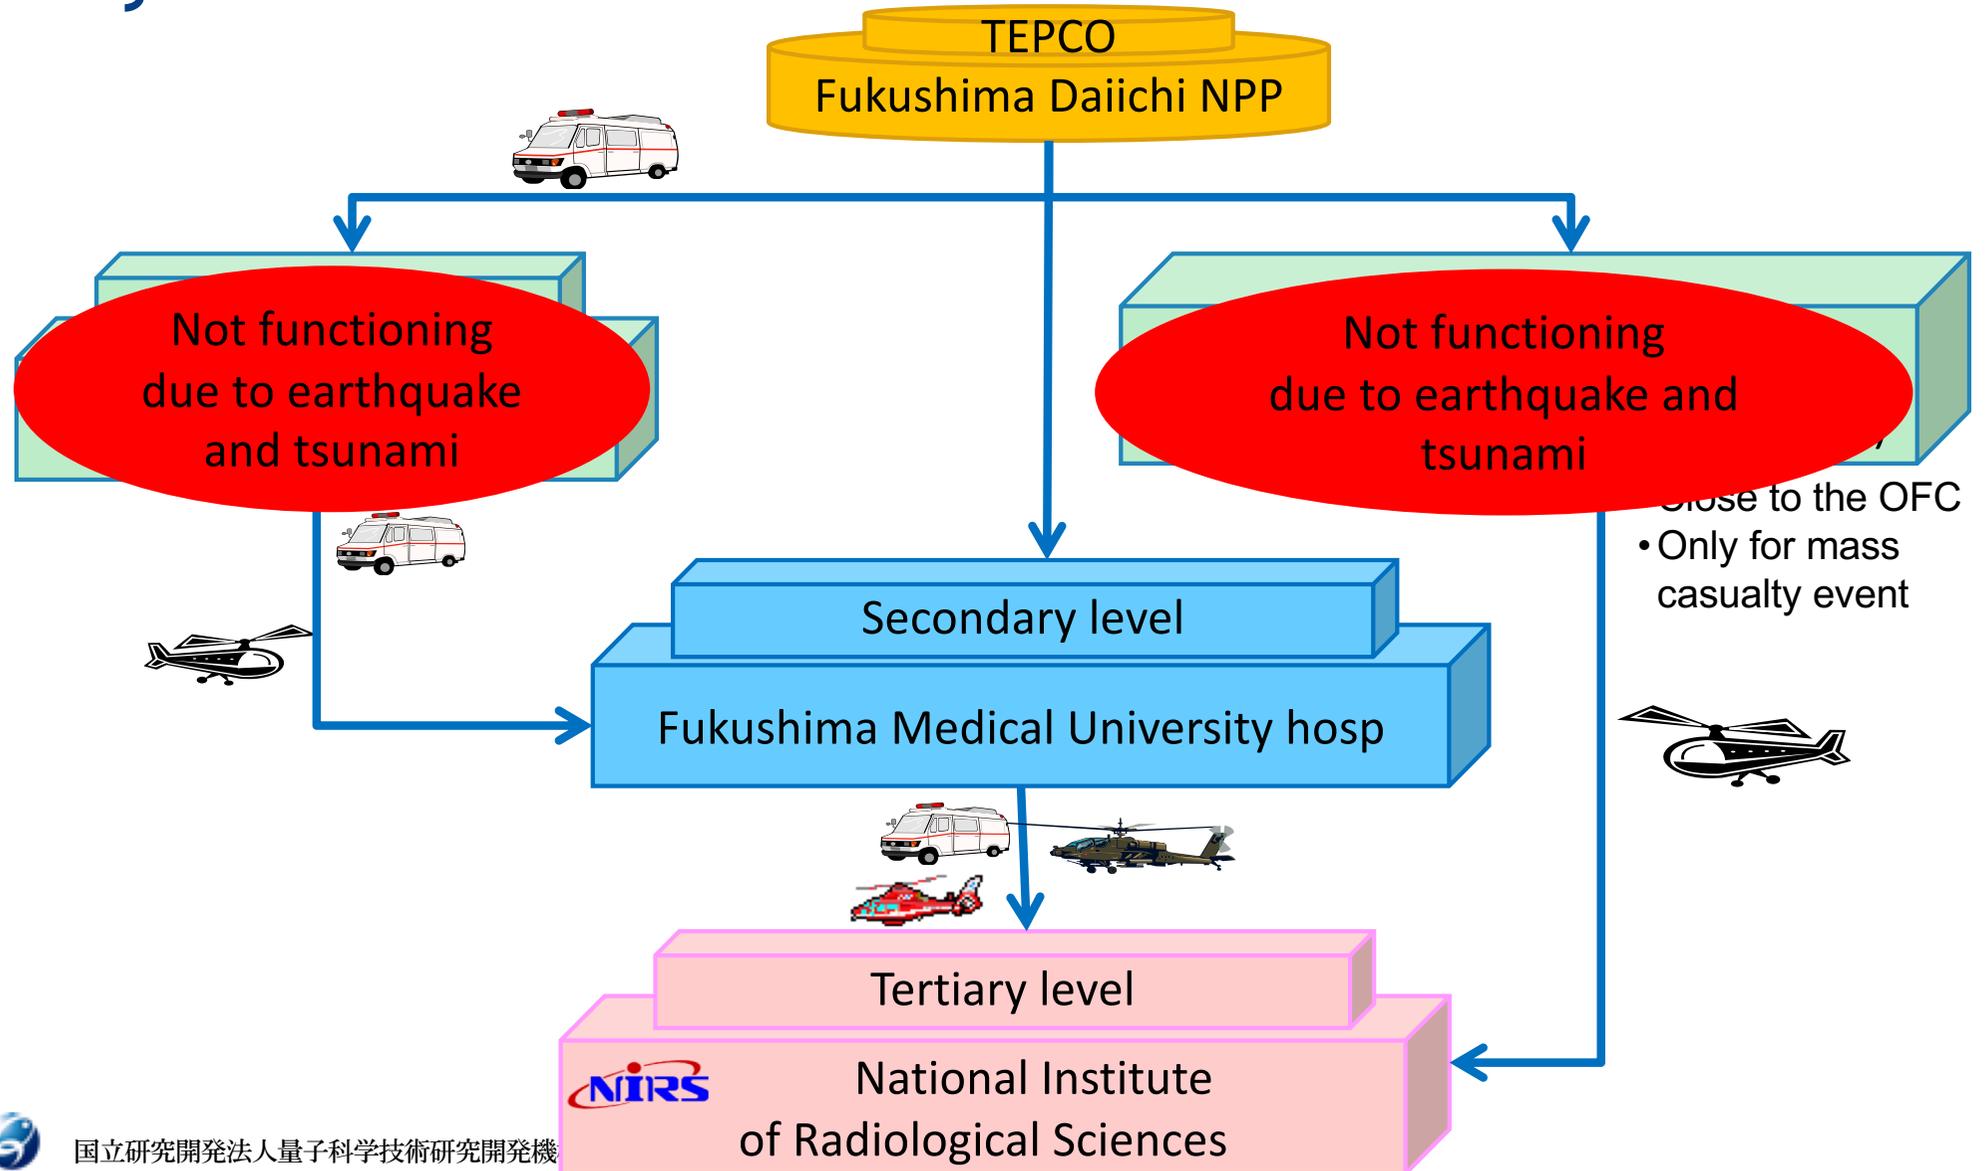
Radiation emergency medical response system in FUKUSHIMA

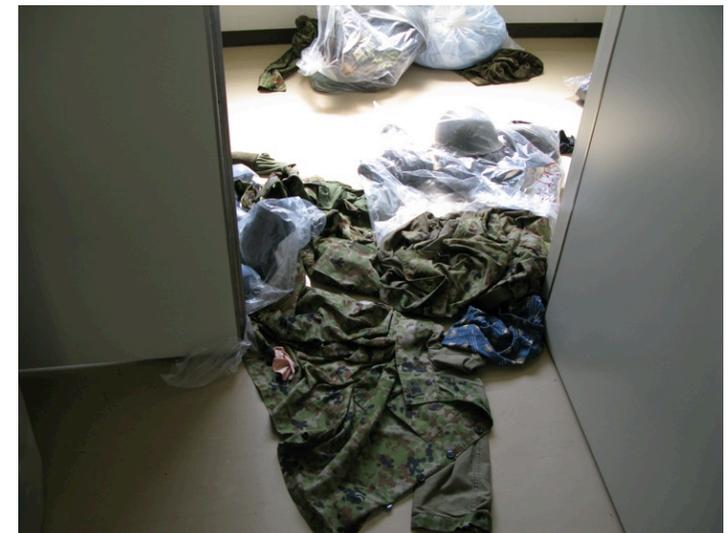
- Took stable iodine before the mission in Fukushima Daiichi NPP
- Hydrogen explosion occurred an hour and 20 minutes after taking stable iodine
- Wore protective gear on his camouflaged uniform, and equipped a full face mask
- Personal dosimeter (PD)

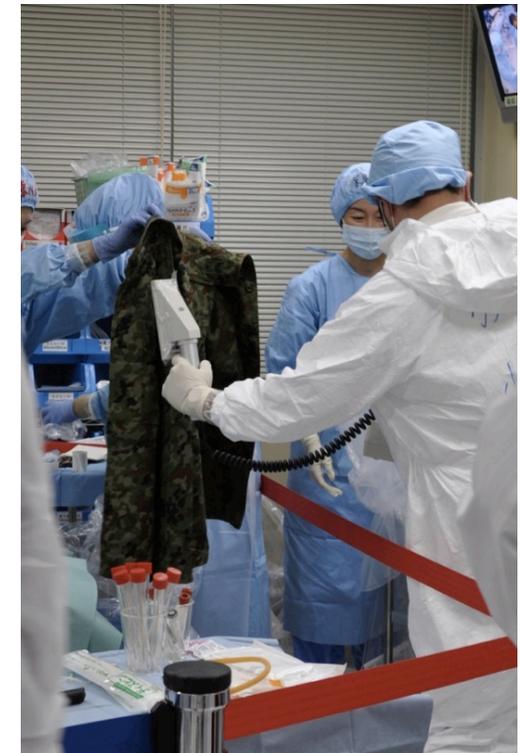
- Arrival at NIRS by JSDF helicopter at 20:30
- Body surface was surveyed with GM counter and the level of external contamination was under 100 kcpm, whereas almost whole body was contaminated
- Level on right thigh wound was 2500 cpm
- Levels of abdominal part was the most prominent (31 kcpm)
- I-131, Te-132 and I-132 were detected from right nasal swab
- Admitted to NIRS hospital
- The exposed doses of experts who took care of patients with contamination were only a few tens of μSv

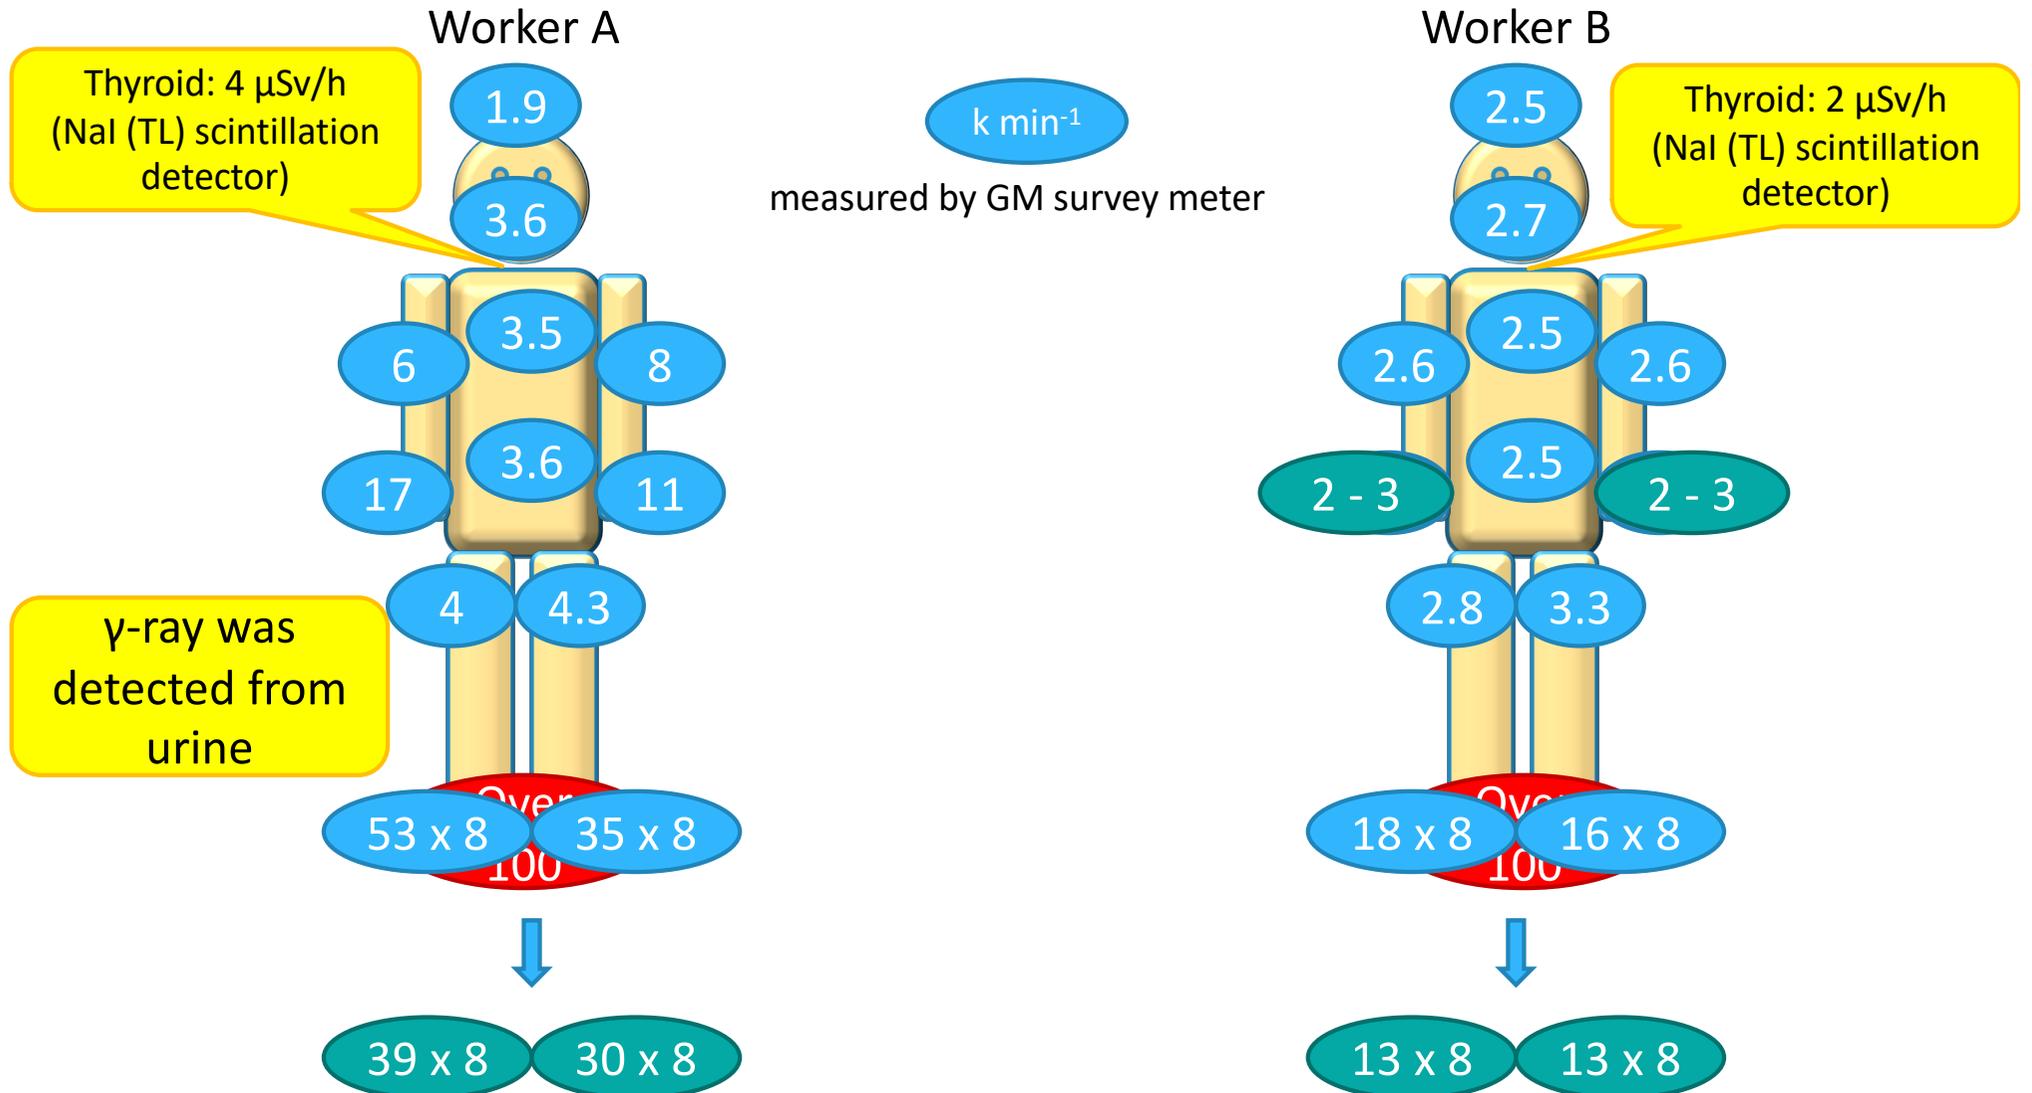
Skin contamination

- The lower part of leg was soaked and heavily contaminated
- The proximal part was contaminated due to wet underwear
- Sole was most heavily contaminated exceeding 100 kcpm with the GM counter

- No cutaneous radiation injury
 - No erythema on their feet
- No specific treatment
- Shower for decontamination every day
- Contamination of sole was decontaminated and reduced to under 100 kcpm with GM
- Discharged on March 28
- Observation for 2 weeks showed no erythema
